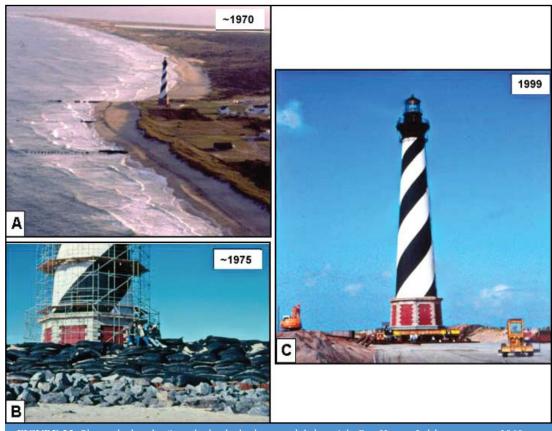
FIGURE 22. Photographs show the effort to harden the shoreline around the base of the Cape Hatteras Lighthouse starting in 1969 with a groin field (Panel A), and with steel sheet-pile bulkhead, rock revetment, and many sandbags by 1975 (Panel B). Landward relocation finally occurred in 1999 (Panel C). All photographs are by S. Riggs.

In North Carolina, one of the earliest ocean-front developments, which began after the Civil War in the area of Old Nags Head, was characterized by very deep lots to allow for the systematic relocation of the houses as the shoreline retreated (Fig. 21A). Most of these early houses were moved landward several times during the 20th century. They are now adjacent to NC Highway 12 and cannot be moved further (Fig. 21B). In 1999, the Cape Hatteras Lighthouse was finally relocated 1600 feet inland after many futile efforts from 1969 to 1999 to combat coastal erosion. Relocation (Fig. 22) can be considered for all buildings that
